# Case Study: Large Metropolitan Municipality

# Quad Plus®

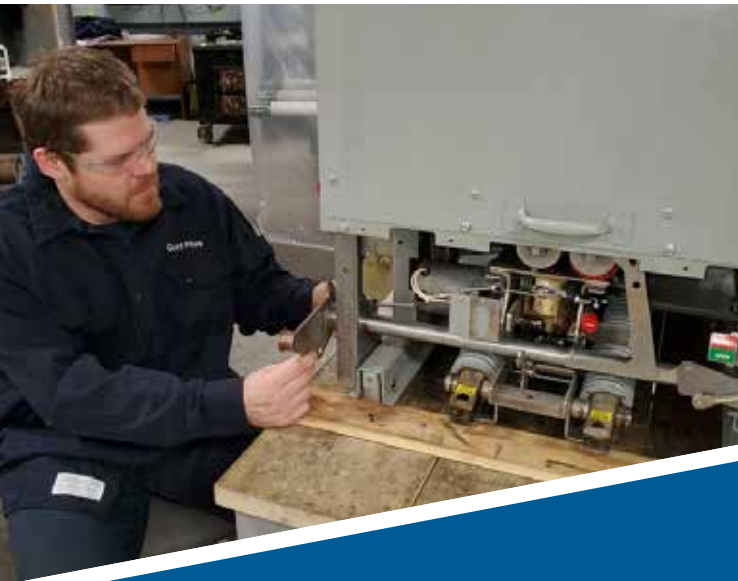
Large municipality reports underground breakers that will not trip and required a cost-effective solution without any major demolition to access the breakers.

A total of (52) 15HK500 breakers, weighing approximately 1500 pounds each, were malfunctioning. Our Shop Manager discovered that the breaker mechanism frames were rusted and the bearings were seized. Therefore, all 52 breakers would have to be removed and evaluated for repair or replacement. To complicate matters, the breakers were located across three underground levels, with 26 on the first level and 26 on the third level.

Our Shop Manager developed a procedure to remove the mechanisms from the breakers on-site that did not require breaking the concrete slab. This not only saved the municipality time, but also cost as well. If the concrete slab had to be removed, additional time and budget would have to be allocated to replace it once the breaker maintenance was complete. The crew would also not require heavy equipment to transport the 1500-pound breakers from the facility. At a rate of five to six breakers per week, the team could manually carry the mechanisms up from the underground levels and to the Quad Plus shop for inspection.

Each mechanism was then tested, repaired, and lubricated in the Quad Plus shop before being transported back to the municipality for reinstallation. The municipality was very impressed with the solution devised by our Shop Manager and the service provided by the team at the Quad Plus Breaker Lab. As a result of this job, we gained a happy, loyal customer.
